Client: Amary Youso
Project Name: Coldwell Banker – Ridgecrest
AED Project No: 19084
Revision: A
Date: August 28, 2019

STRUCTURAL OBSERVATION REPORT

Anacapa Engineering and Design, Inc. was contacted to perform a structural observation following some earthquake activity in the Ridgecrest area. Anacapa Engineering and Design, Inc. performed a structural observation at the commercial building located at 1305, 1307, 1309, 1311, 1313, 1315, 1317 N. Norma St, Ridgecrest, CA 93555.

SECOND STRUCTURAL OBSERVATION REPORT

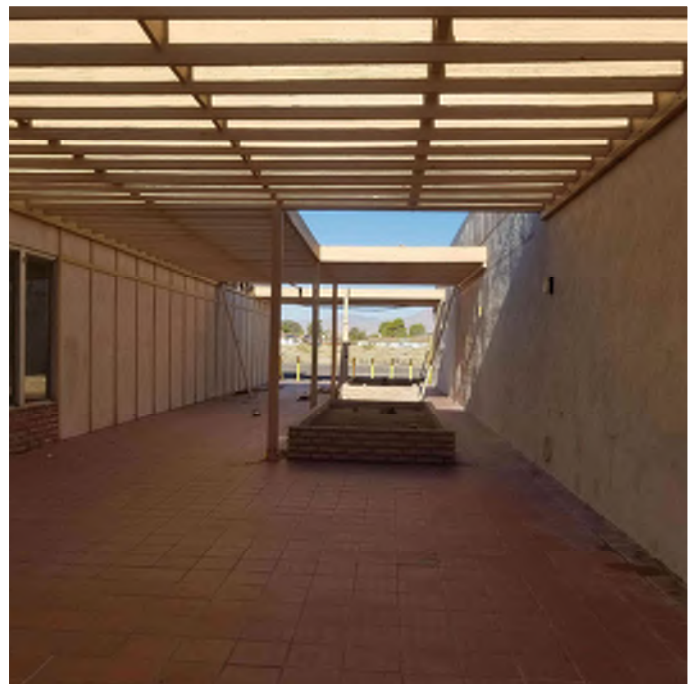
1. Facade has numerous cracks; some have been repaired and some have not. (See photos I-L)
2. Inter-connecting breezeways beams have shifted and show signs of dry rot. (See photo H)
3. Cracks in the stucco at the rear of the building. (See photo M)
4. Eastern wall pulled away from main building and partially collapsed the roof. (See photos N-Q)
5. Front covered walkway framing members and connections show signs of movement. (See photos R-T)

Photo H - Inter-connecting breezeway

1. Building Façade - Contractor to expose framing behind façade for more in depth investigation during second site visit.
2. Inter-connecting breezeways - Contractor to remove and replace in-kind all rotted beams, joist, ledgers, etc.

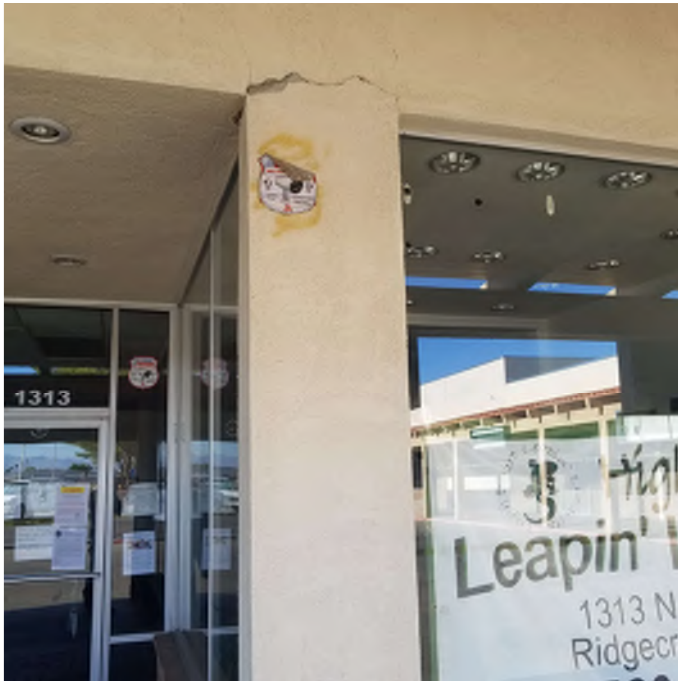
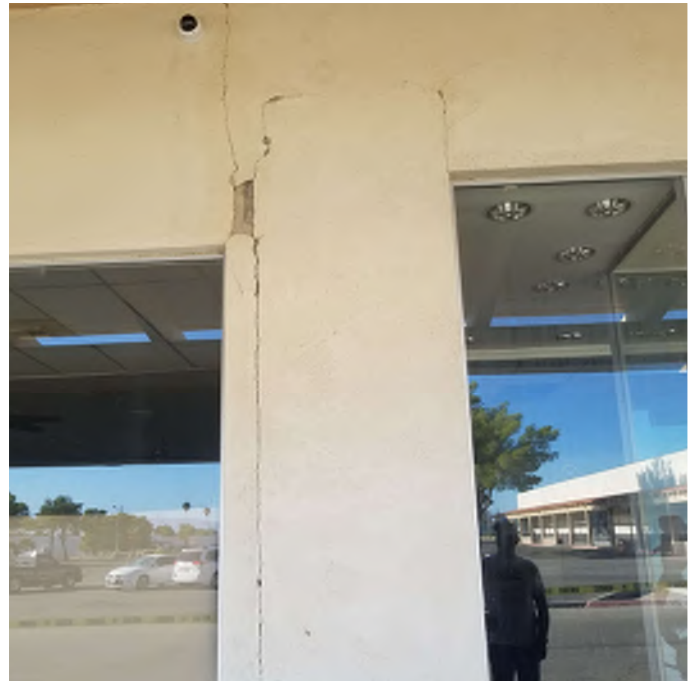
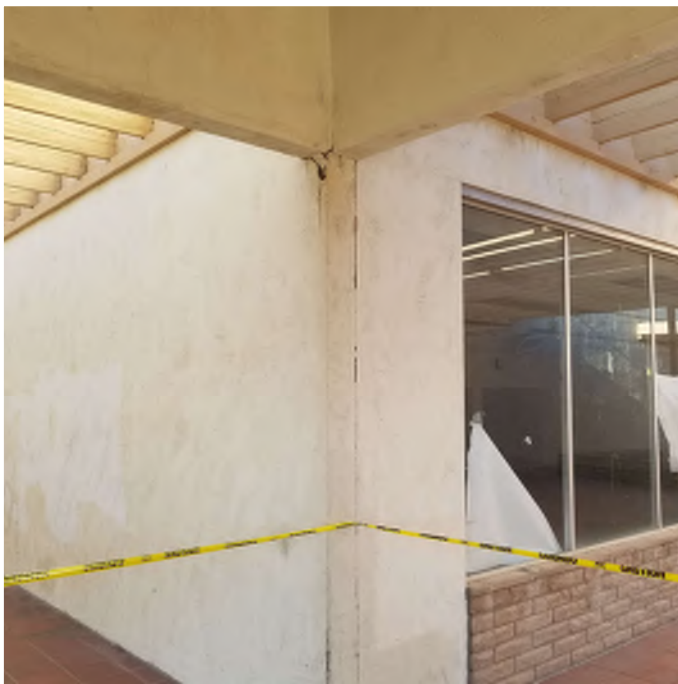
Photo I - Crack on facade

Photo J - Crack on facade

Photo K - Crack on facade

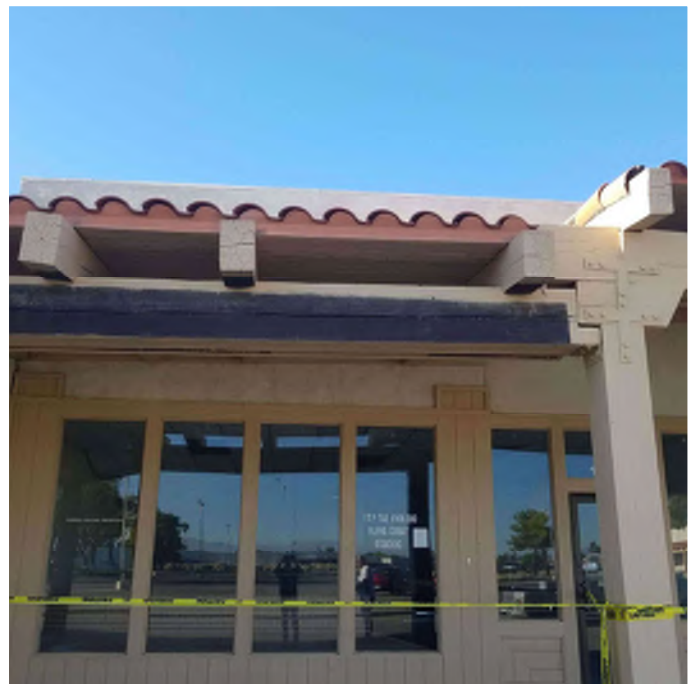
Photo L - Beam shifted

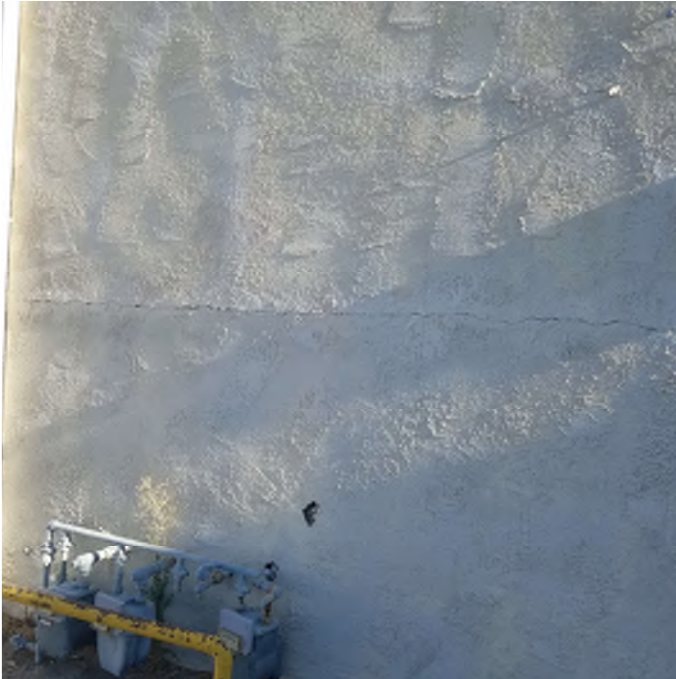
Photo M- Crack at back wall

3. Rear Walls - Contractor to expose framing behind stucco for more in depth investigation during second site visit.
4. Leaning wall and collapsed roof – Contractor to remove some of the ceiling to better expose the connections at the beams to wall connections. This should be established at a couple locations with in the building. Contractor should also expose other locations if possible, like at interior columns, interior separation walls between suites, etc. This would help in the assessment of the existing structure.

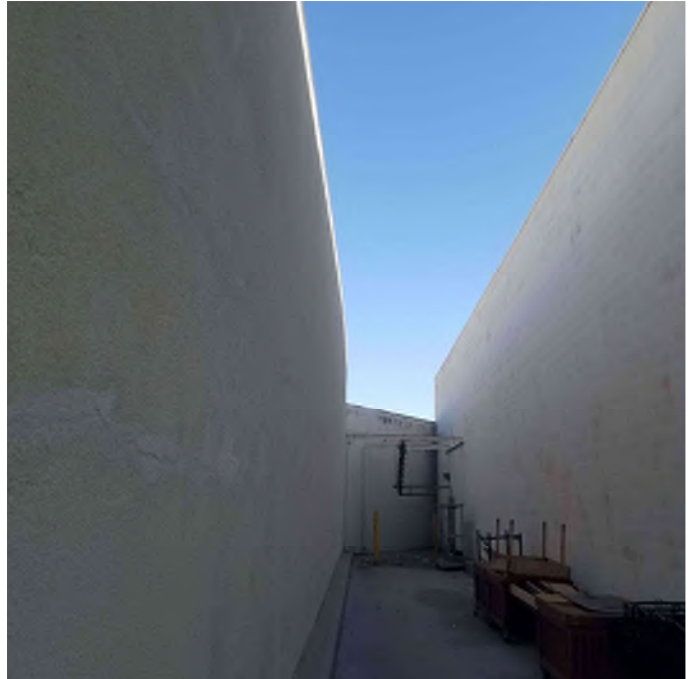
Photo N - Eastern wall leaning away from building

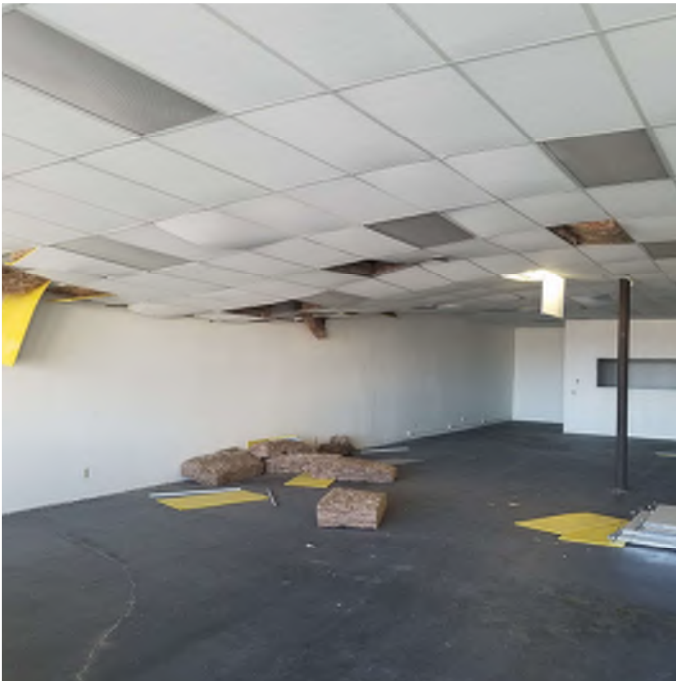
Photo O - Ceiling partially collapsed

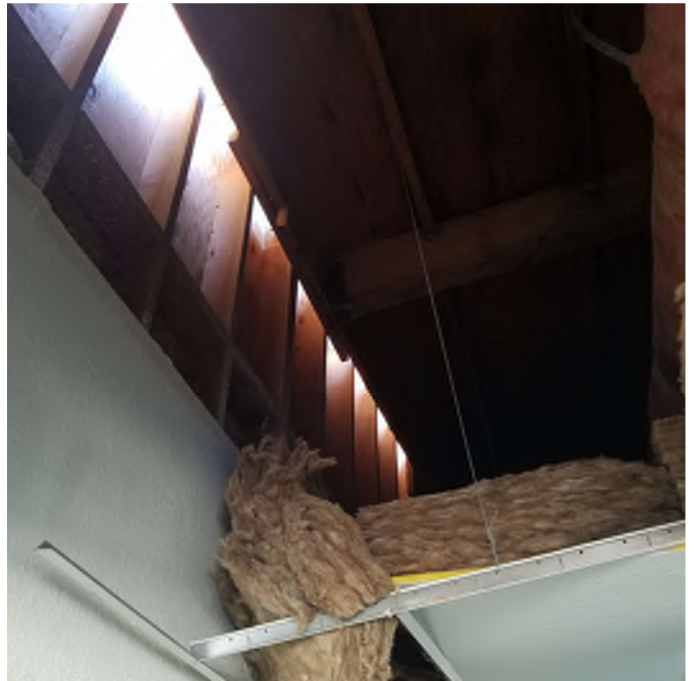
Photo P - Roof partially collapsed inside of the leaning wall

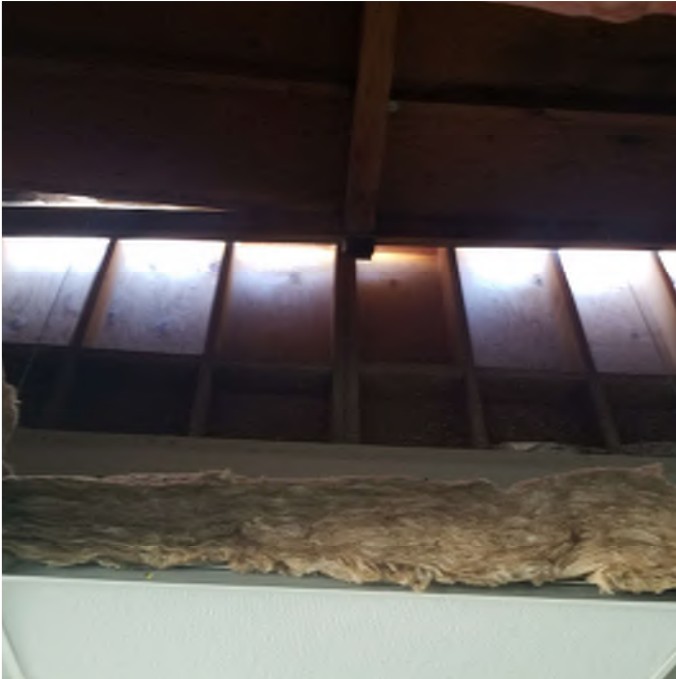
Photo Q - Roof detached from exterior wall

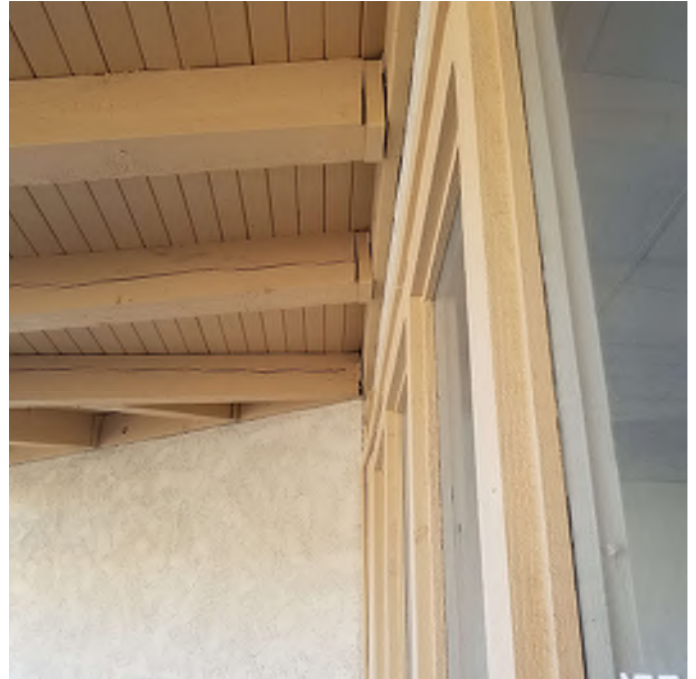
Photo R - Walkway cover beams pulling away from beam buckets

5. Contractor to inspect and verify adequate bearing in connections.
 - a. If inadequate, framing member and connections to be replaced in-kind.

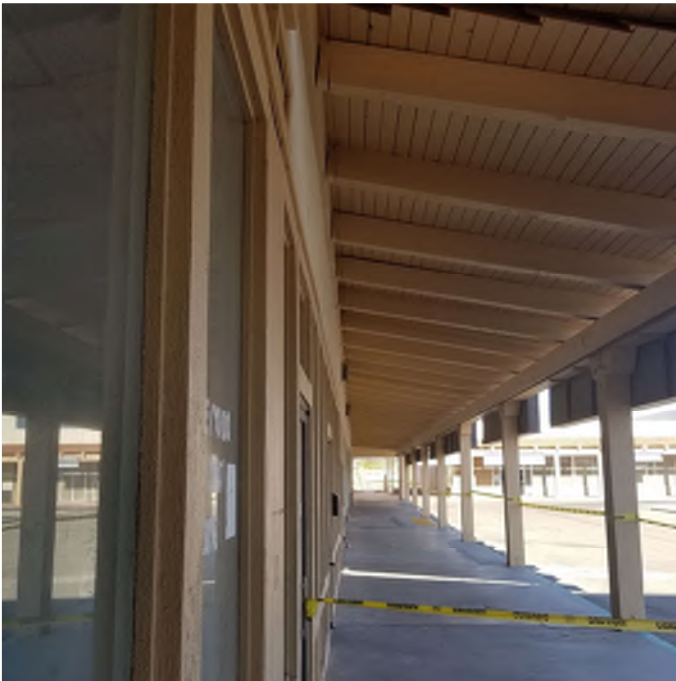
Photo S - Walkway cover

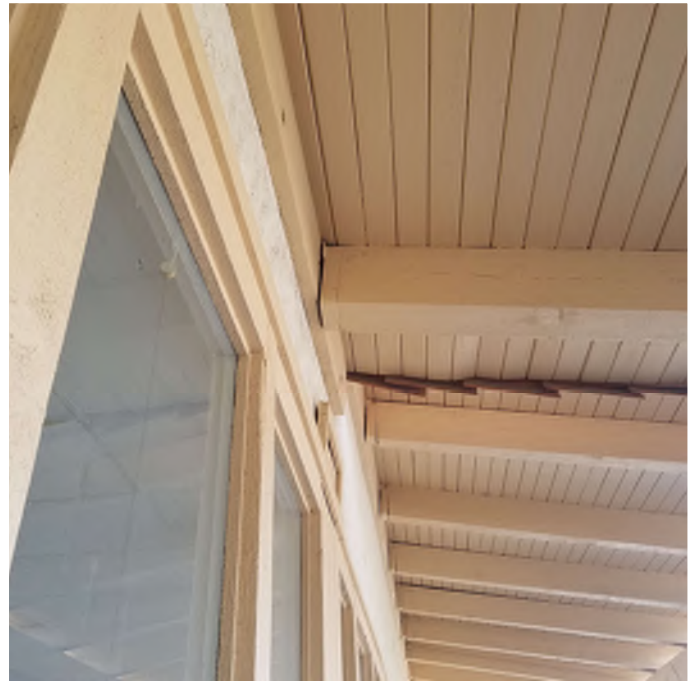
Photo T - Walkway cover beams

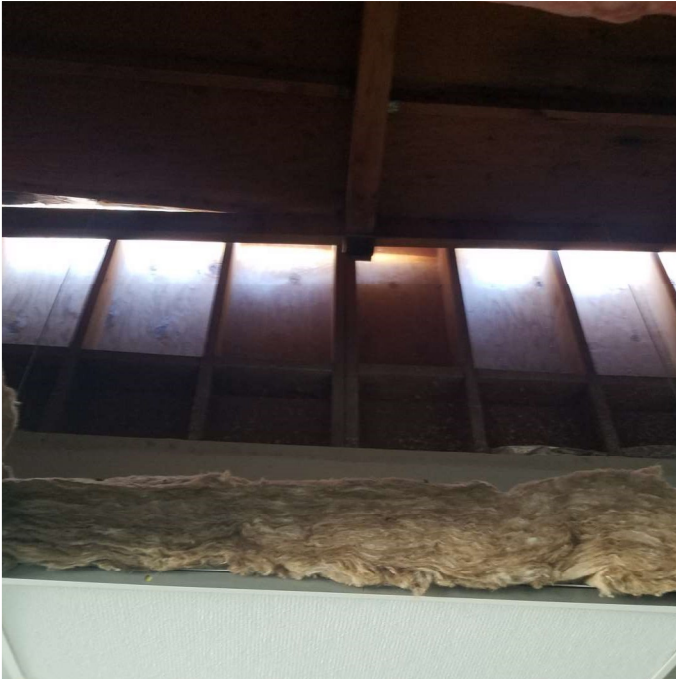
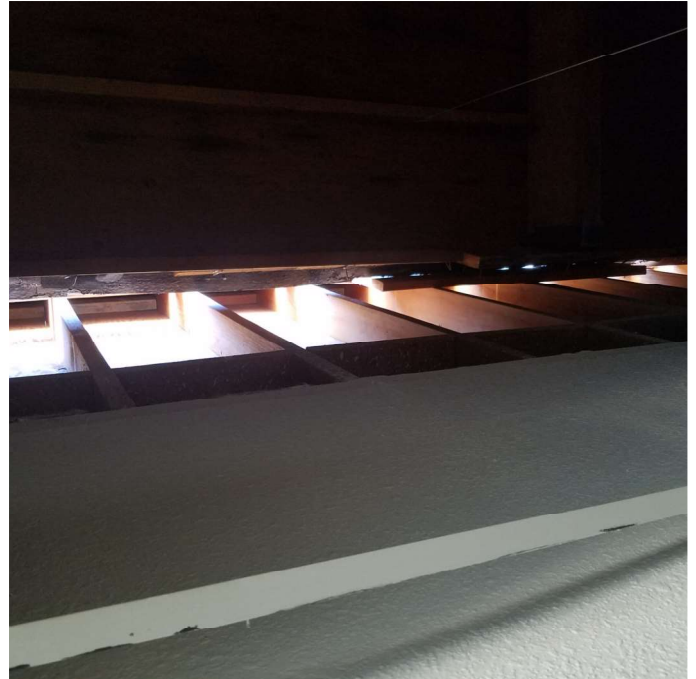
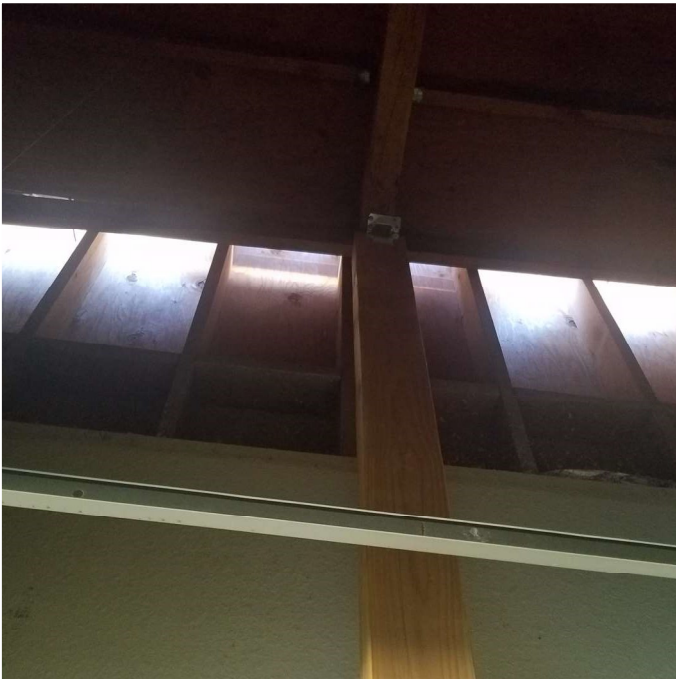
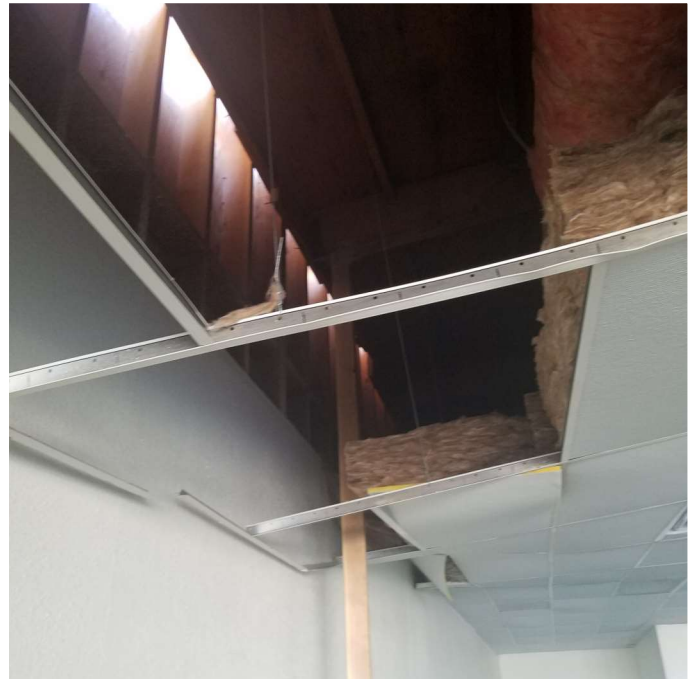
3. Ledger.
 - a. Requirement: A portion of the roof/ceiling along the eastern wall has pulled away from the exterior wall. See photos 5 thru 8. It appears that the nails holding the joist have pulled out of the wall. The roof framing should be lifted back in place and temporarily supported. The wall should then be moved back in place and the roof framing reconnected to the wall. The re-connection should be in accordance with Details A & B.

- b. Requirement: The entire perimeter wall to roof framing connection should be retrofitted as indicated on Details A & B.
4. Interior Non-bearing Walls.
